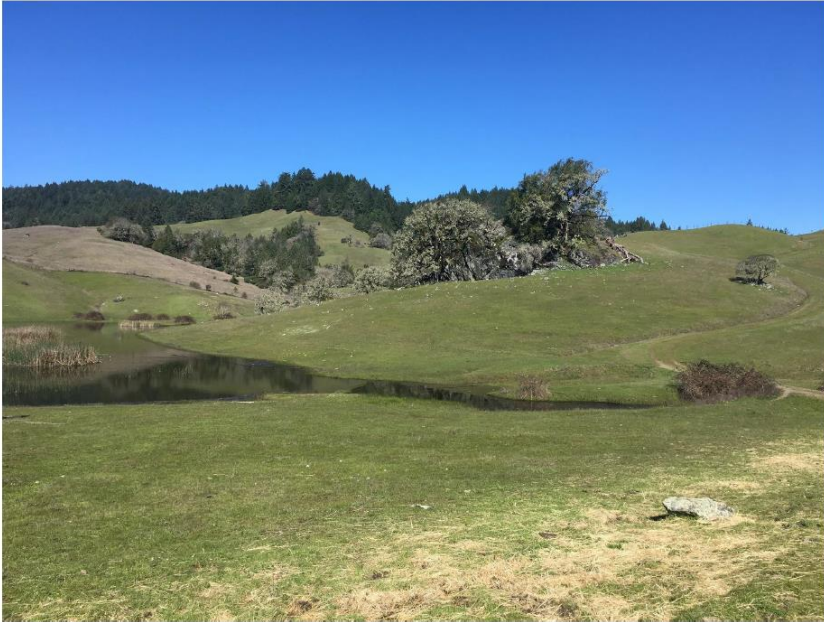
Photo 1 – Northeastern edge of reservoir, facing northwest.

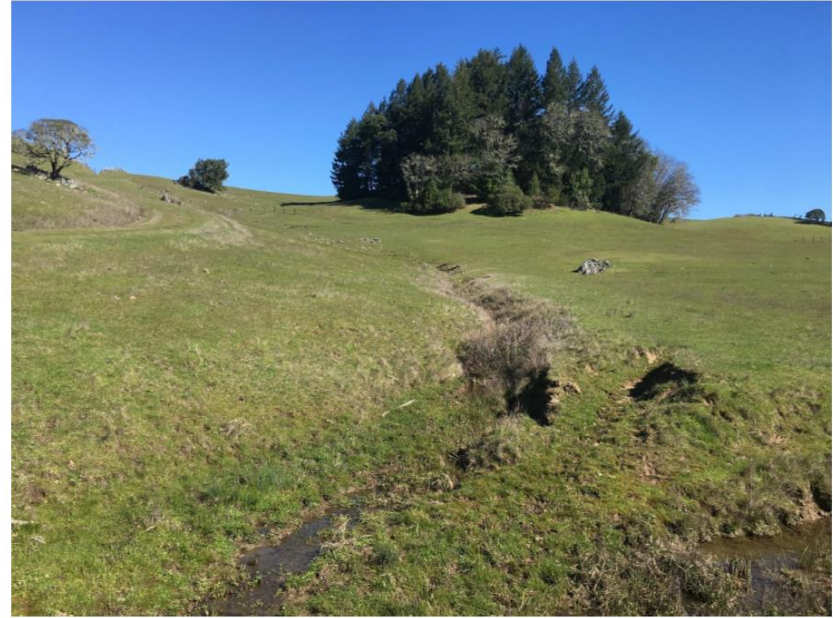
Photo 2 – Northern side of reservoir, facing north. One unnamed stream enters the reservoir from the north.

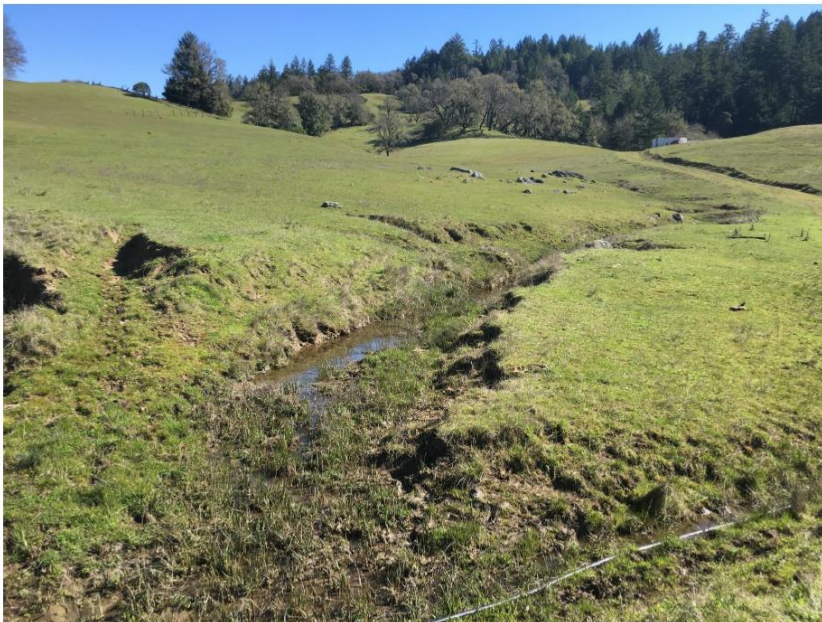
Photo 3 – Northern side of reservoir, facing northeast. A second unnamed stream enters the reservoir from the northeast.

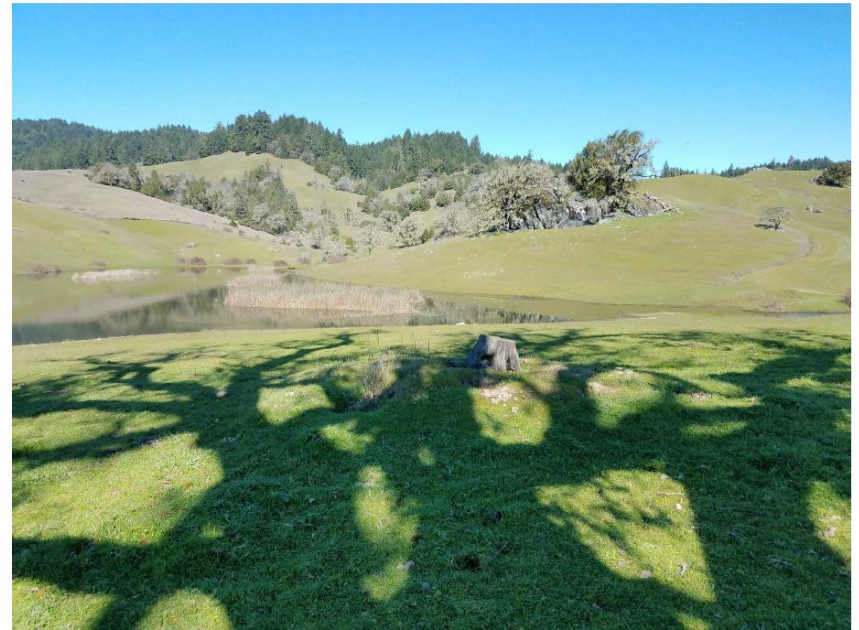
Photo 4 – Eastern side of reservoir, facing northwest. This is the upper end of the reservoir.

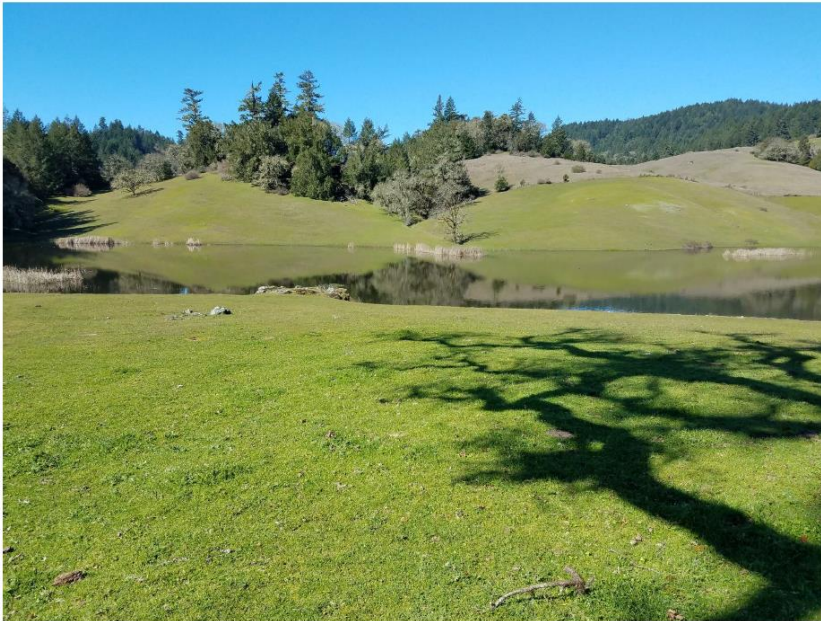
Photo 5 – Eastern side of reservoir, facing west. This is the middle of the reservoir.

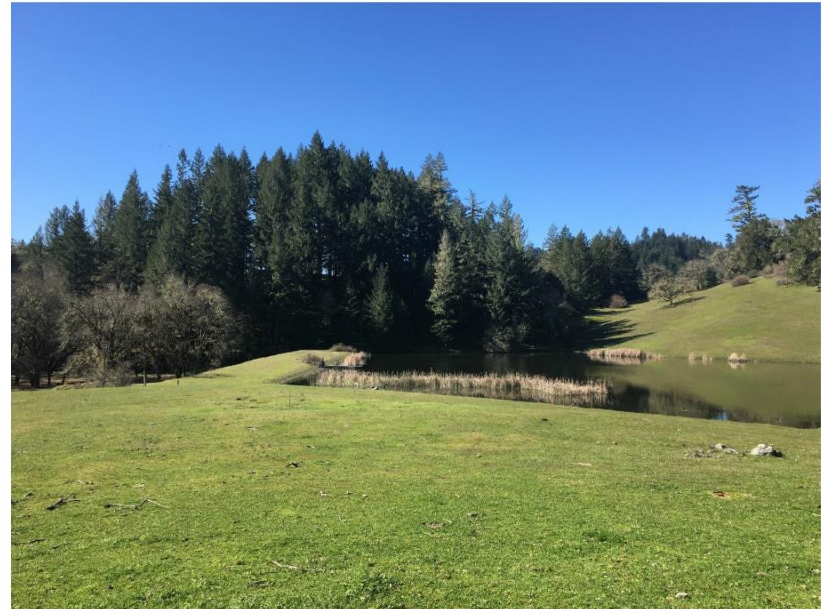
Photo 6 – Eastern side of reservoir, facing west. This is the lower end of the reservoir and the dam.

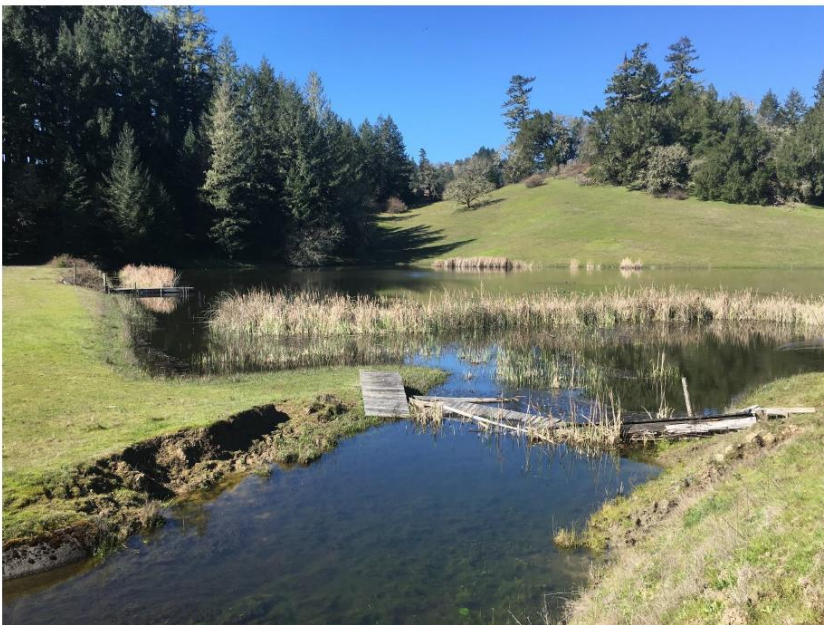
Photo 7 – Lower end of reservoir, dam and spillway, facing west.

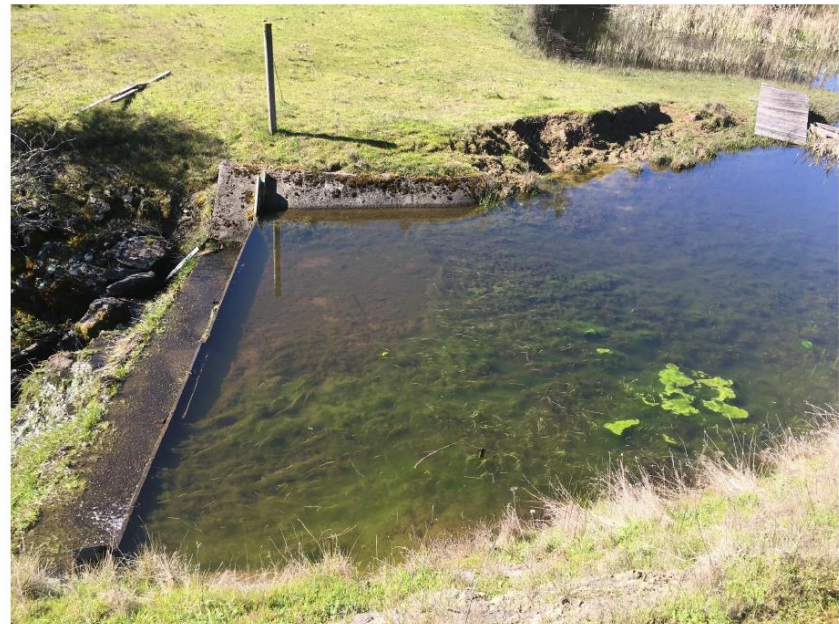
Photo 8 – Spillway, facing west.

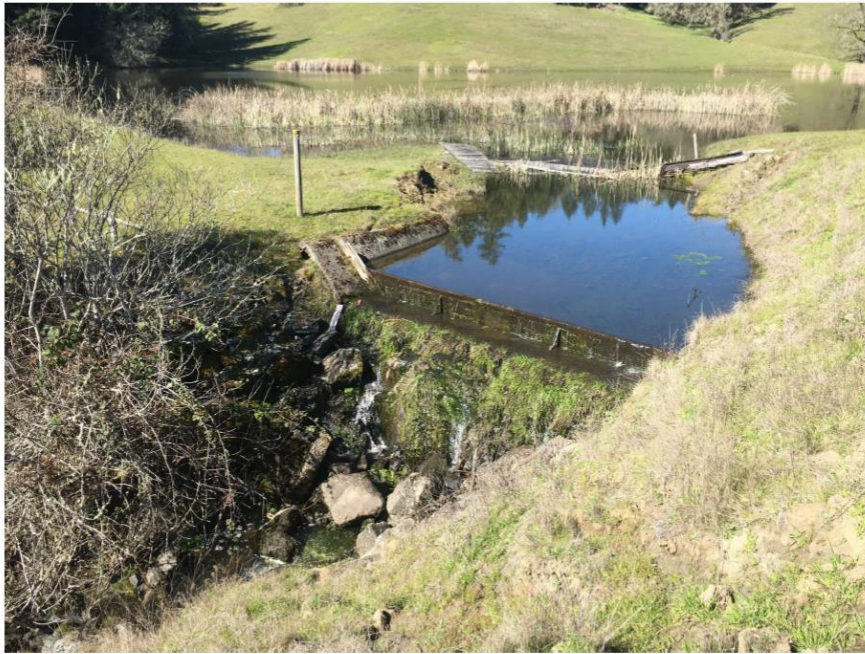
Photo 9 – Spillway and area below spillway, facing northwest.

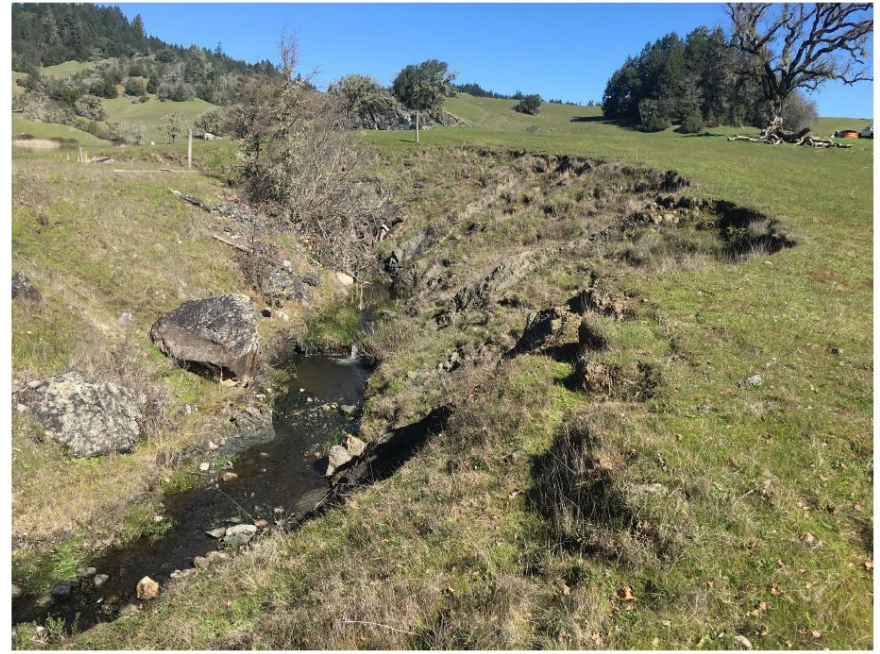
Photo 10 – Unnamed stream channel approximately 50 feet below spillway, facing north.

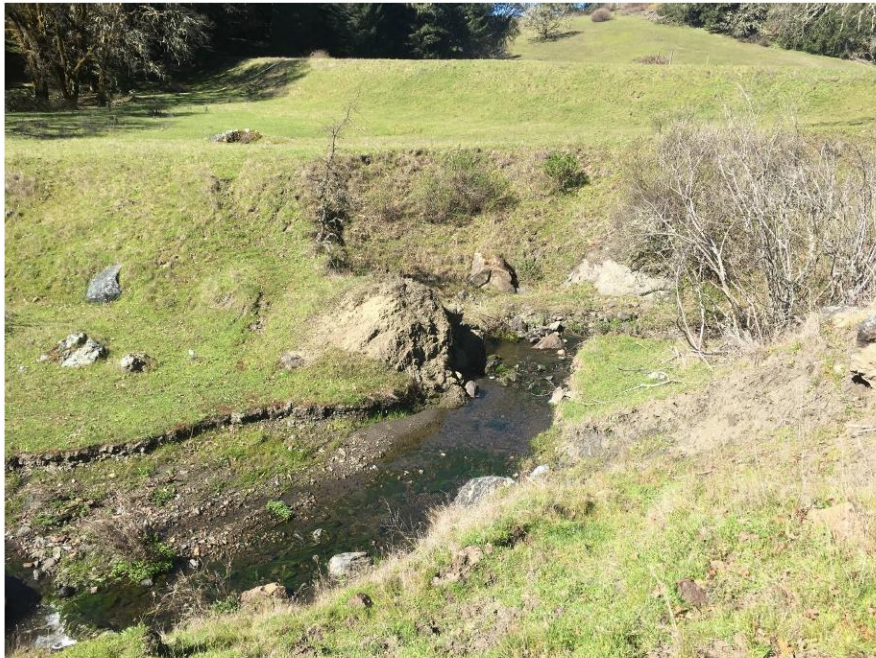
Photo 11 – Unnamed stream channel approximately 100 feet below spillway, facing northwest.

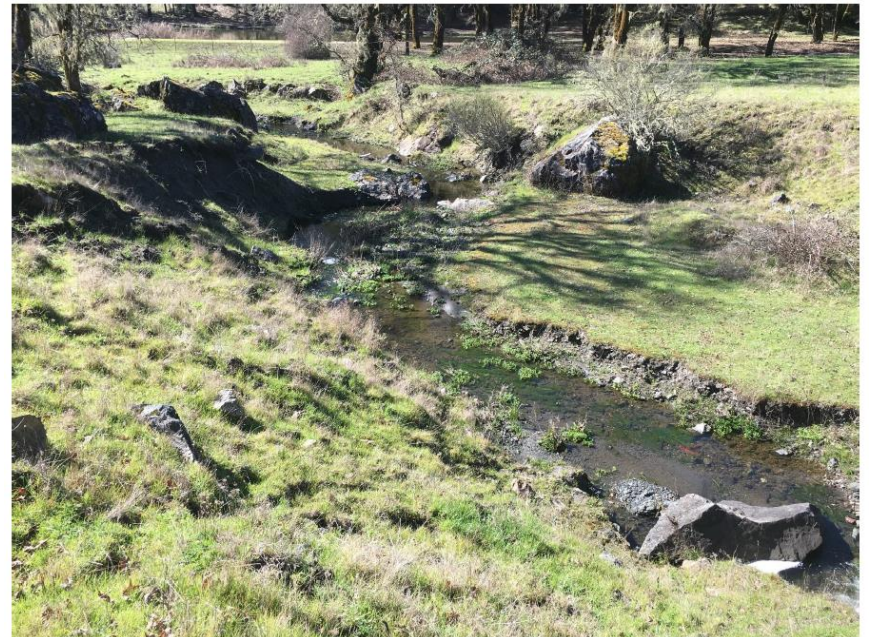
Photo 12 – Unnamed stream channel approximately 150 feet below spillway, facing southwest.  
The fishing pond is visible in the background of this photograph.

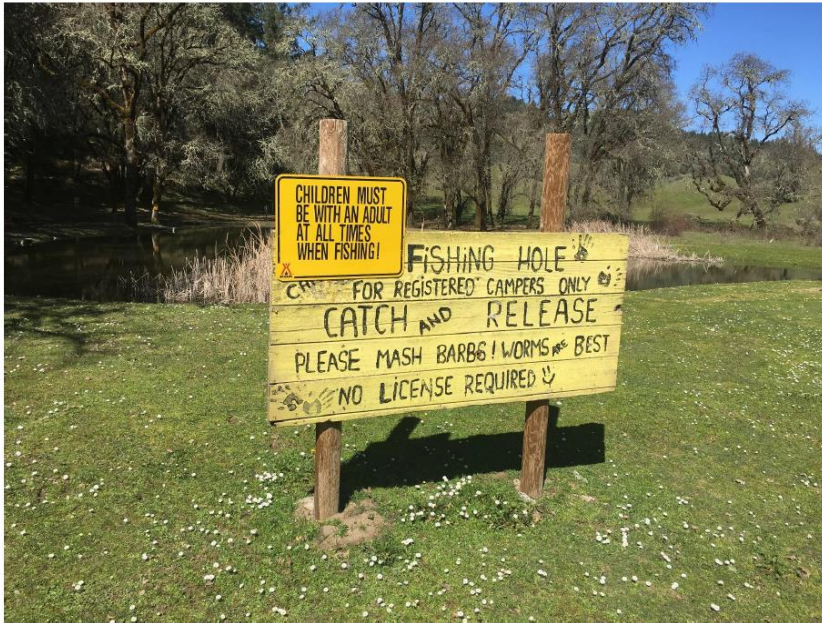
Photo 13 – Fishing pond operated by the Willits KOA, facing northeast.

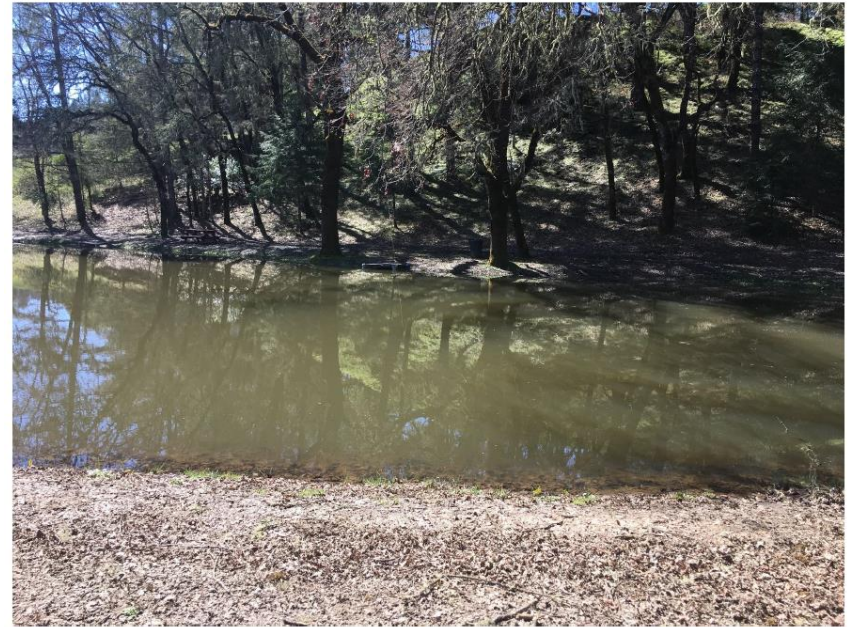
Photo 14 – Fishing pond operated by the Willits KOA, facing southwest.

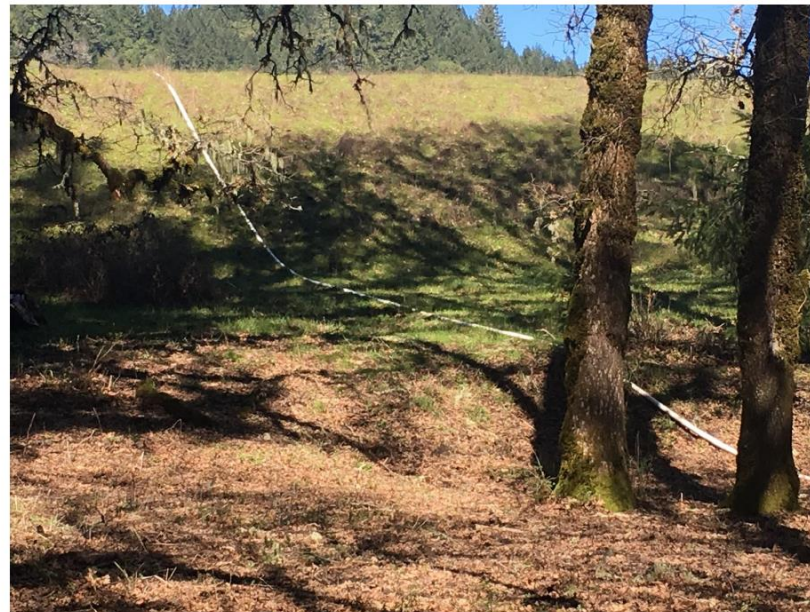
Photo 15 – View of the dam from below, and PVC transfer line from the reservoir to the fishing pond facing northwest.
